CONNECTICUT RIVER FLOOD CONTROL

DAM & RESERVOIR

DESIGN MEMORANDUM NO. 6

SITE GEOLOGY

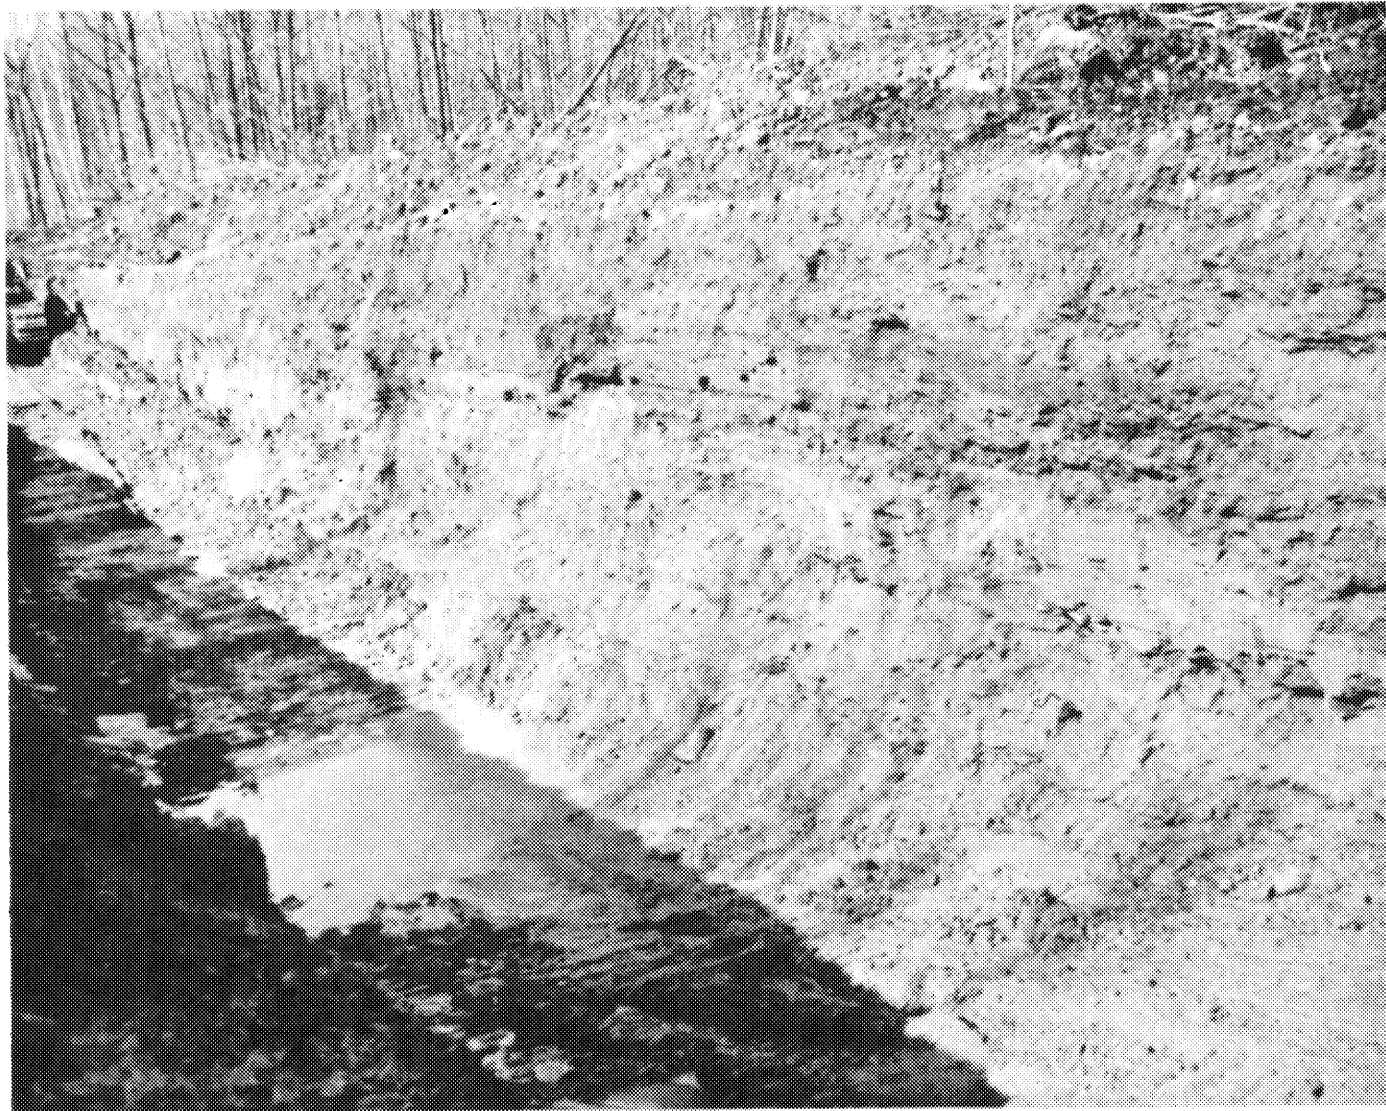
BORROW AREA FOR RANDOM AND IMPERVIOUS EMBANKMENT FILL MATERIALS
EXPLORATORY TEST TRENCH IN GLACIAL TILL

21. Impervious and Random Materials. Materials suitable for the construction of the impervious and random sections of the dam, and the relocated Wales Road, are available in required quantity from a borrow area established above the height of dam on the left abutment as shown on the General Plan and Reservoir Map, Plate No. 6-1. These materials comprise a variable deposit of glacial till which can be divided into two zones, upper and lower, based on the composition and degree of compactness. Figure 2 shows an excavated section of the glacial till. The 7 to 10 foot thick upper zone consists of brown to gray, gravelly silty sand with numerous cobbles. The upper material will be used to construct the random fill sections of the embankments. The lower zone, which is 10 to over 30 feet in thickness, consists principally of gray, compact to very compact, silty medium to fine sand, with occasional sections of gravelly silty sand and cobbles. This material will be used to construct the impervious fill section of the dam embankment. From observations made in an exploration test trench, and in observation wells over a period of 6 months, it appears that the subsurface water level in this area varies from 10 to 30 feet below ground surface following the slope of the hill. Some water is also believed to be perched on the top of the lower zone of the till. The hillside position of the area will facilitate drainage during excavation.
